Case Study: Cardiac Resynchronisation Device Far-Field Oversensing with Transvenous Pacing Device

Healy L, Fitzpatrick N, Jauvert G, Tahin T, Galvin J, Szeplaki G, O'Brien J*
Mater Private Hospital, Eccles St, Dublin, Ireland.

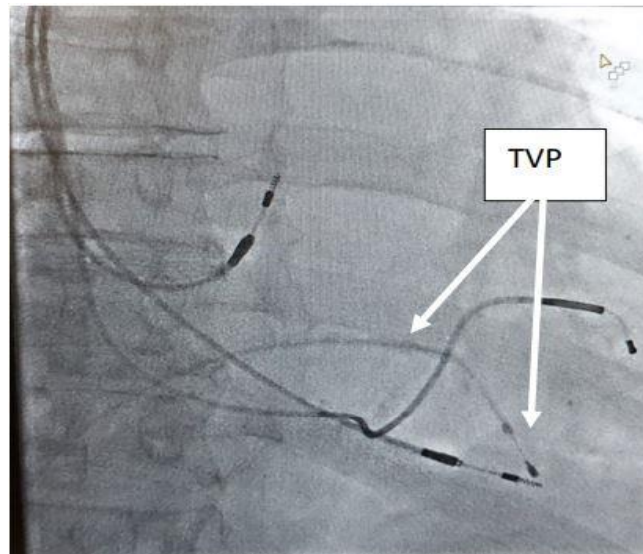
Figure 1. Close proximity of transvenous pacing wire (TVP) to distal electrode of CRT-RV lead (RAO projection)

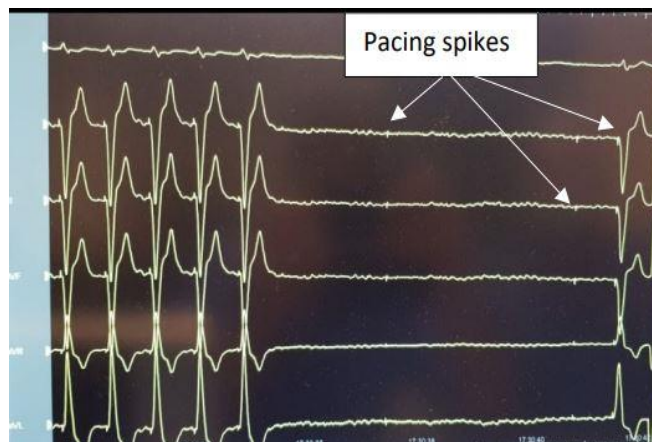
Figure 2. Asystole noted with decremental output during threshold testing from the TVP, note the pacing spikes of the TVP on the isoelectric line

This case is the first to report the potential hazard of cross-talk between two pacing devices in close proximity. Reducing sensitivity, programming a VOO backup mode or re-positioning of the leads should usually resolve the issue. Operators should be aware of this potential complication when placing a TVP near a pace-sense lead in patients who are 100% pacing dependent.
